Manhole Inspection Summary

Manhole # S41I__019MH

Insp Date: **5/15/08 10:28 AM**

Location Address: **210 s central ave**

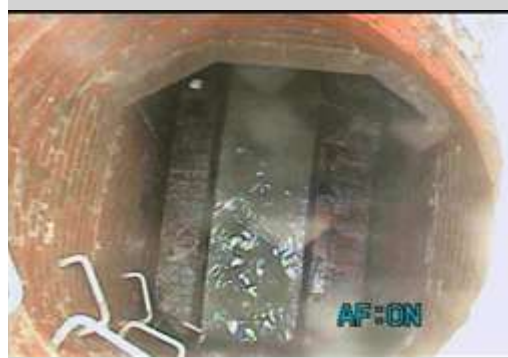
Top View

top view & steps

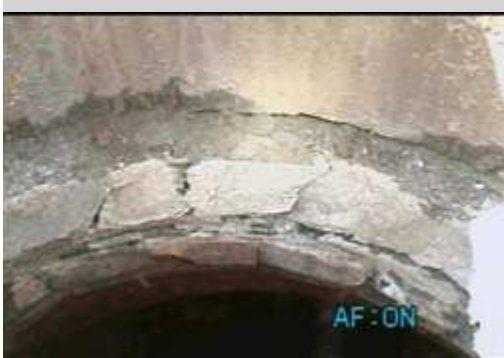
Defect 1

Offset: **2** (in.)

Condition: ☐ Sound ☐ Cracked ☐ Root Intrusion ☒ **Loose Brick** ☐ Deteriorated

offset, loose bricks

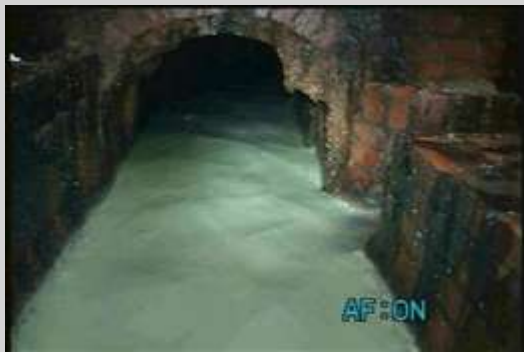
12 O'Clock Outflow

27 in. Circular Gravity Sewer
Pipe Out @ 12 O'Clock

Infiltration: **None** Pipe Seal Cond: **Unknown**

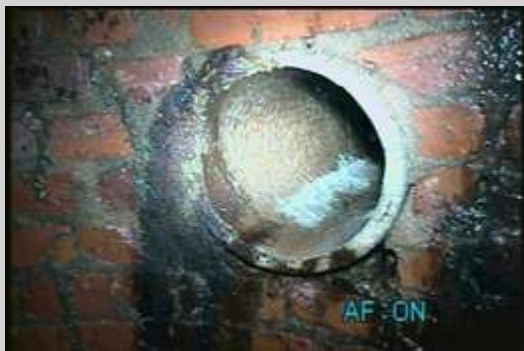
3 O'Clock Inflow

8 in. Circular Gravity Sewer
Pipe In @ 3 O'Clock

Infiltration: **None** Pipe Seal Cond: **Unknown**

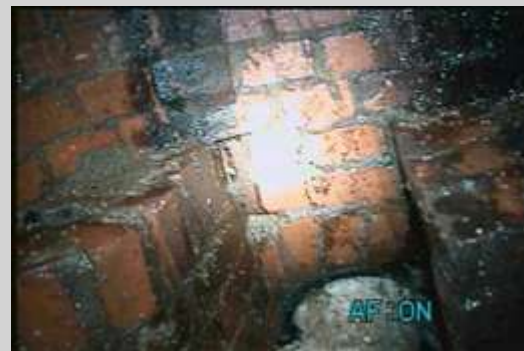
Drop In @ 3 O'Clock

under shelf couldnt get better picture

Drop: **Outside Direct**

Drop Condition: **Clogged**

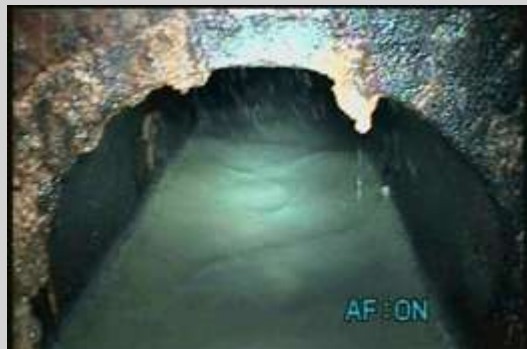
6 O'Clock Inflow

27 in. Circular Gravity Sewer
Pipe In @ 6 O'Clock

Infiltration: **None** Pipe Seal Cond: **Unknown**
